Title		Pages:
ENVIRONMENTAL QUALIFICATION TEST REPORT OF RAYCHEM NUCLEAR CABLE BREAKOUT AND END SEALING KITS		34
WYLE REPORT NO. 58442-2		Enclosures:
Report Number:	Date:	
EDR-5033	May 1, 1981	
Tested by:	Signature:	Date:
Wyle Laboratories	(see report)	April 3, 1981
Prepared by:	Signature:	Date:
C. F. Albertalli	<i>C. F. Albertalli</i>	<i>May 1, 1981</i>
Approved by:	Signature:	Date:
R. J. Scott for Product Management	<i>R. J. Scott</i>	<i>1 May 81</i>
Approved by:	Signature:	Date:
G. J. Clarke for Technical Operations	<i>G. J. Clarke</i>	<i>May 1 81</i>
Raychem Corporation Energy Division

REPORT NO. 58442-2
OUR JOB NO. NDQ 58442
CONTRACT ---
YOUR P. O. NO. A01183

ENVIRONMENTAL QUALIFICATION TEST REPORT
OF
RAYCHEM NUCLEAR CABLE BREAKOUT AND END SEALING KITS
FOR
RAYCHEM CORPORATION
MENLO PARK, CALIFORNIA

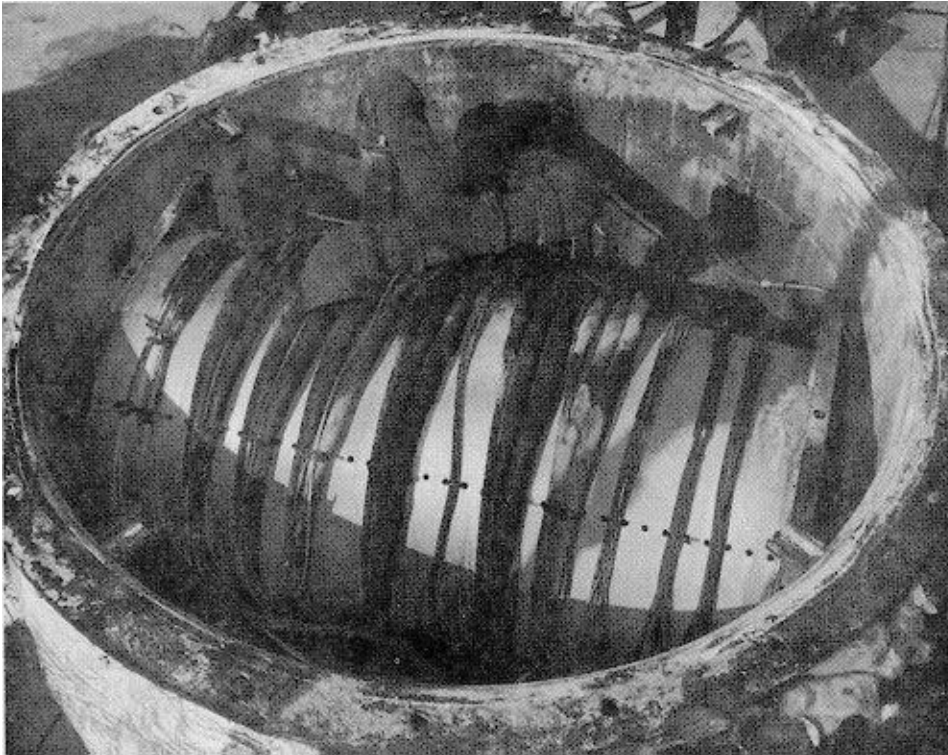
FIGURE 8. Test Chamber and Samples

The extension wires were cut inside the vessel so that the mandrel could be removed. This also allowed the test vessel penetrations to be inspected. It was found that some of the wires in the penetration had a low insulation resistance and would not pass the 3.6kV a-c voltage withstand test. The specimens associated with the penetration wires having a low

insulation resistance were retested immersed in water (see Figure 4). The retest of specimens 2-1R, 2-2B, and 2-5W2 showed high values of insulation resistance and all specimens passed the voltage withstand test. The low values previously measured on these specimens can therefore be attributed to the test vessel penetrations and not the specimens.

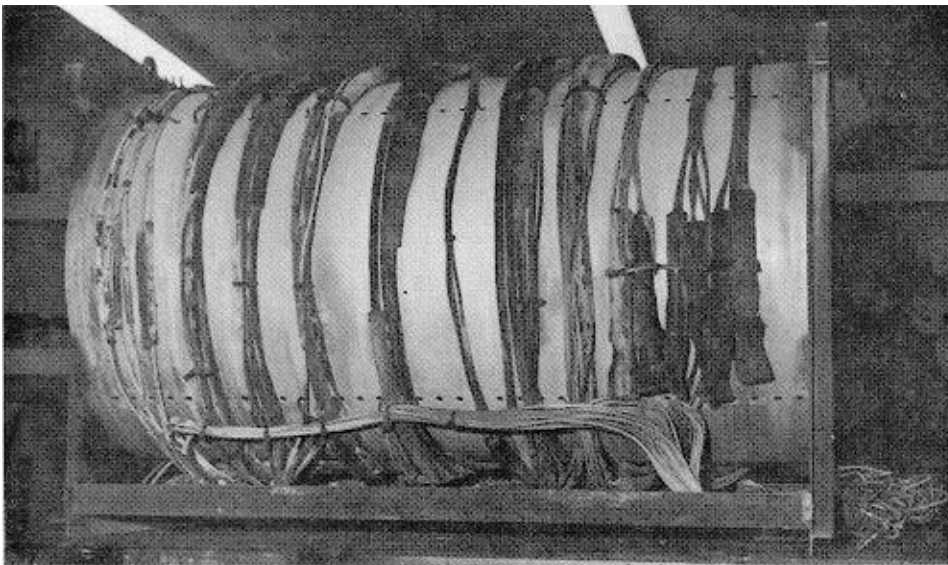
FIGURE 9. Mandrel After Removal from Vessel

Some specimens had high values of insulation resistance throughout the simulated LOCA/MSLB test but dropped in insulation resistance or did not pass the voltage withstand test when the vessel was flooded with water. It was found that the low values were caused by cracks in the extension wire insulation away from the mandrel area. The samples again had high insulation resistance values and passed the voltage withstand test when the mandrel was removed from the vessel, the extension wires repaired, and the mandrel re-immersed in water. The insulation values are given in Table 1.

The remaining specimens had cracked wire insulation on the test loops around the mandrel. In these cases, the specimens were removed from the mandrel and individually immersed in water for test. In this way, the cracked wire could be isolated. The remaining specimens, except 2-5B, gave high insulation resistance values and passed the voltage withstand tests when tested with the cracked wire insulation out of the water. This could not be done with specimen 2-5B since the crack in the wire insulation was too close to the end of the cable breakout. An insulation resistance value could not be obtained on this specimen because the surface leakage gave an erroneous value. This specimen did, however, pass the voltage withstand test using an aluminum foil ground plane.

End cap assembly 2-IW1 had a dielectric failure through the end of the cap after repeated over-voltage testing (up to 6kV a-c) used to locate the cracked wire insulation during the post-test investigation. The failure occurred at the end of the cap where the cut strands of the No. 12 wire contacted the end cap.

Visual examination of the sleeves used over the cable breakouts and end caps showed surface degradation and some superficial crazing. This was most apparent on specimens 2-4 and 2-5.
