Title		Pages:
ENVIRONMENTAL QUALIFICATION TEST REPORT OF RAYCHEM NUCLEAR CABLE BREAKOUT AND END SEALING KITS		34
WYLE REPORT NO. 58442-2		Enclosures:
Report Number:	Date:	
EDR-5033	May 1, 1981	
Tested by:	Signature:	Date:
Wyle Laboratories	(see report)	April 3, 1981
Prepared by:	Signature:	Date:
C. F. Albertalli	<i>C. F. Albertalli</i>	<i>May 1, 1981</i>
Approved by:	Signature:	Date:
R. J. Scott for Product Management	<i>R. J. Scott</i>	<i>1 May 81</i>
Approved by:	Signature:	Date:
G. J. Clarke for Technical Operations	<i>G. J. Clarke</i>	<i>May 1 81</i>
Raychem Corporation Energy Division

REPORT NO. 58442-2
OUR JOB NO. NDQ 58442
CONTRACT ---
YOUR P. O. NO. A01183

ENVIRONMENTAL QUALIFICATION TEST REPORT
OF
RAYCHEM NUCLEAR CABLE BREAKOUT AND END SEALING KITS
FOR
RAYCHEM CORPORATION
MENLO PARK, CALIFORNIA

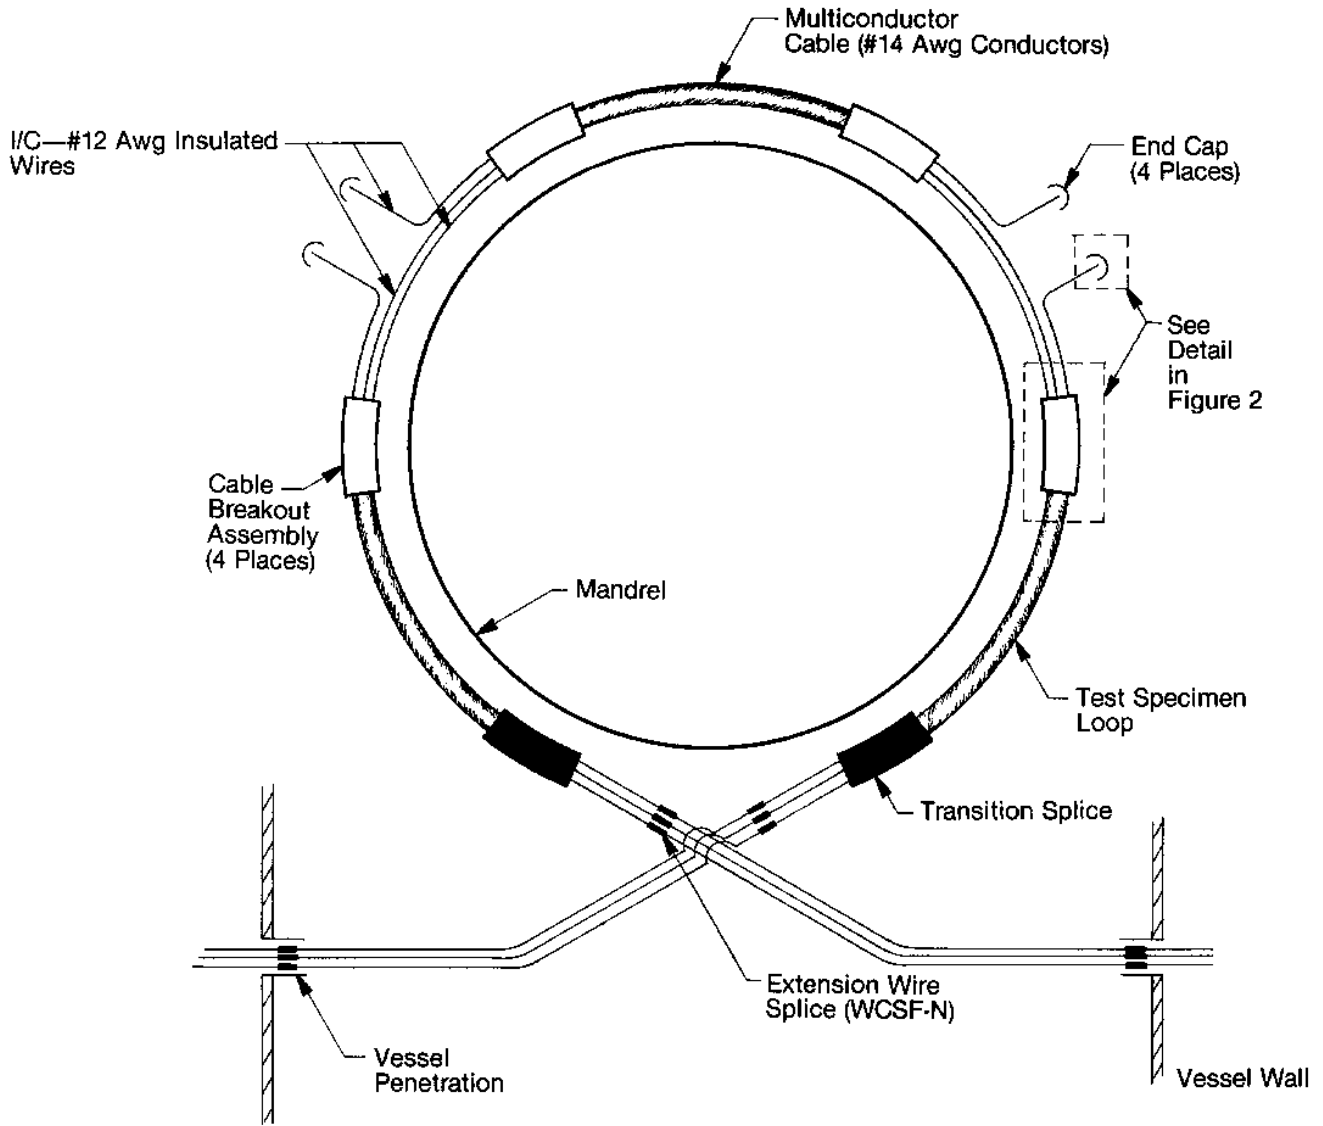
Figure 1 SAMPLE CONSTRUCTION

Each test specimen was comprised of four cable breakouts and four end caps forming a loop as shown in Figure 1. The cable breakouts were tested as part of a transition splice assembly

The wire insulations in the test specimen loops were color coded for ease of identification during the test. The red and black wires were continuous throughout the test loops and had voltage and current applied. The white wire was terminated in end caps at four places as shown in Figure 1 and therefore could not have current applied. Voltage was applied to the white wire from each end of the test loop. The white wire in the two cable breakout assemblies and end caps in the middle of the test loop was isolated and could not be energized.

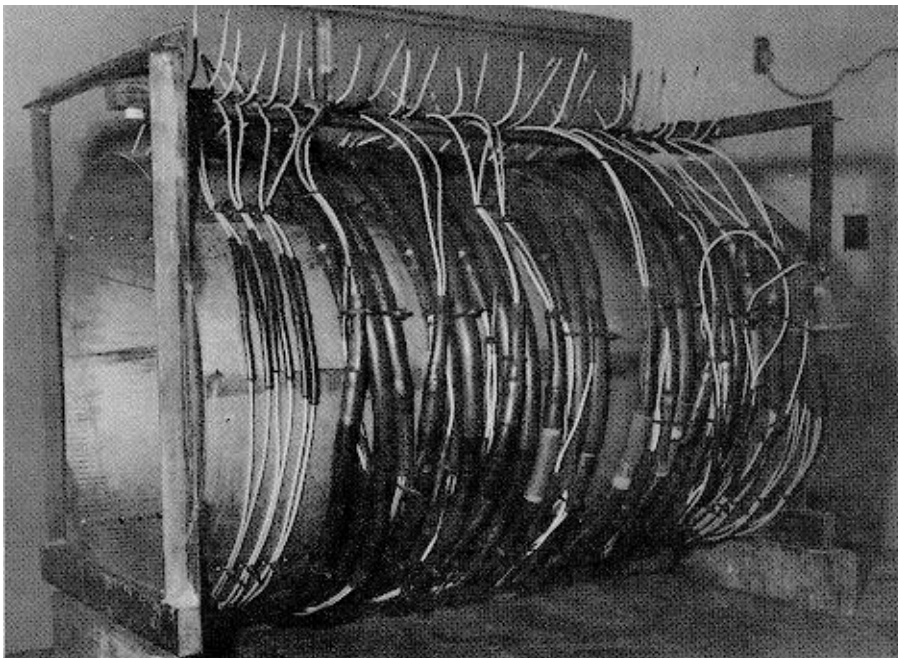
FIGURE 3. Mandrel and Samples
(Specimens 2-1 through 2-6 are located
in the center section of the mandrel.)

The mandrel, with the specimens in place, is shown in Figure 3.

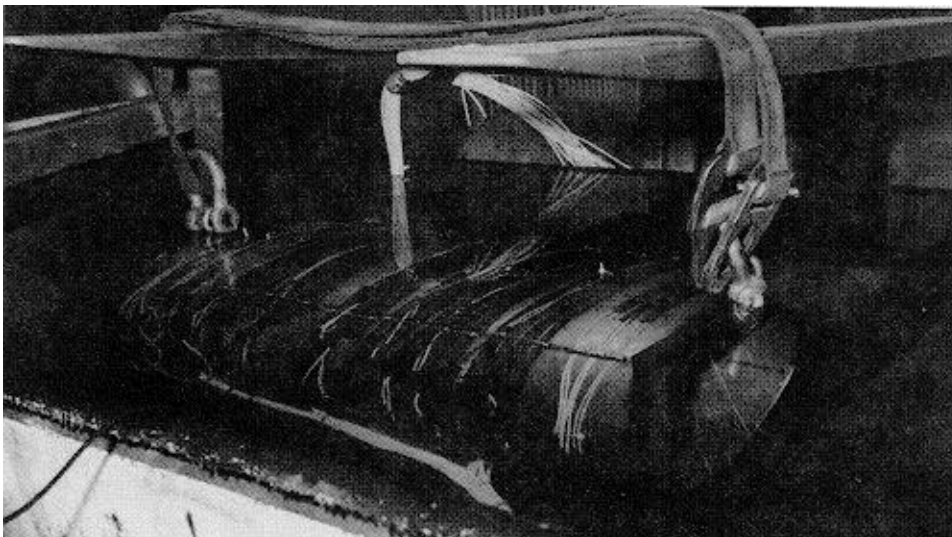
FIGURE 4. Mandrel and Samples Immersed in Water

The mandrel with the specimens in place was immersed in water for functional tests as described in 3.1.1. This was accomplished by splicing long extension leads to each end of the test loops. The splices between the specimens and the extension leads were covered with WCSF-N heat shrinkable tubing. The mandrel in the water is shown in Figure 4.

All specimens again passed the 3.6kV a-c voltage withstand test for five minutes. The insulation resistance values are given in Table 1 on page 14.

insulation resistance were retested immersed in water (see Figure 4). The retest of specimens 2-1R, 2-2B, and 2-5W2 showed high values of insulation resistance and all specimens passed the voltage withstand test. The low values previously measured on these specimens can therefore be attributed to the test vessel penetrations and not the specimens.
